NIST NCSTAR 1-5A

**Federal Building and Fire Safety Investigation of
the World Trade Center Disaster**

Visual Evidence, Damage Estimates, And Timeline Analysis

William M. Pitts
Kathryn M. Butler
Valentine Junker

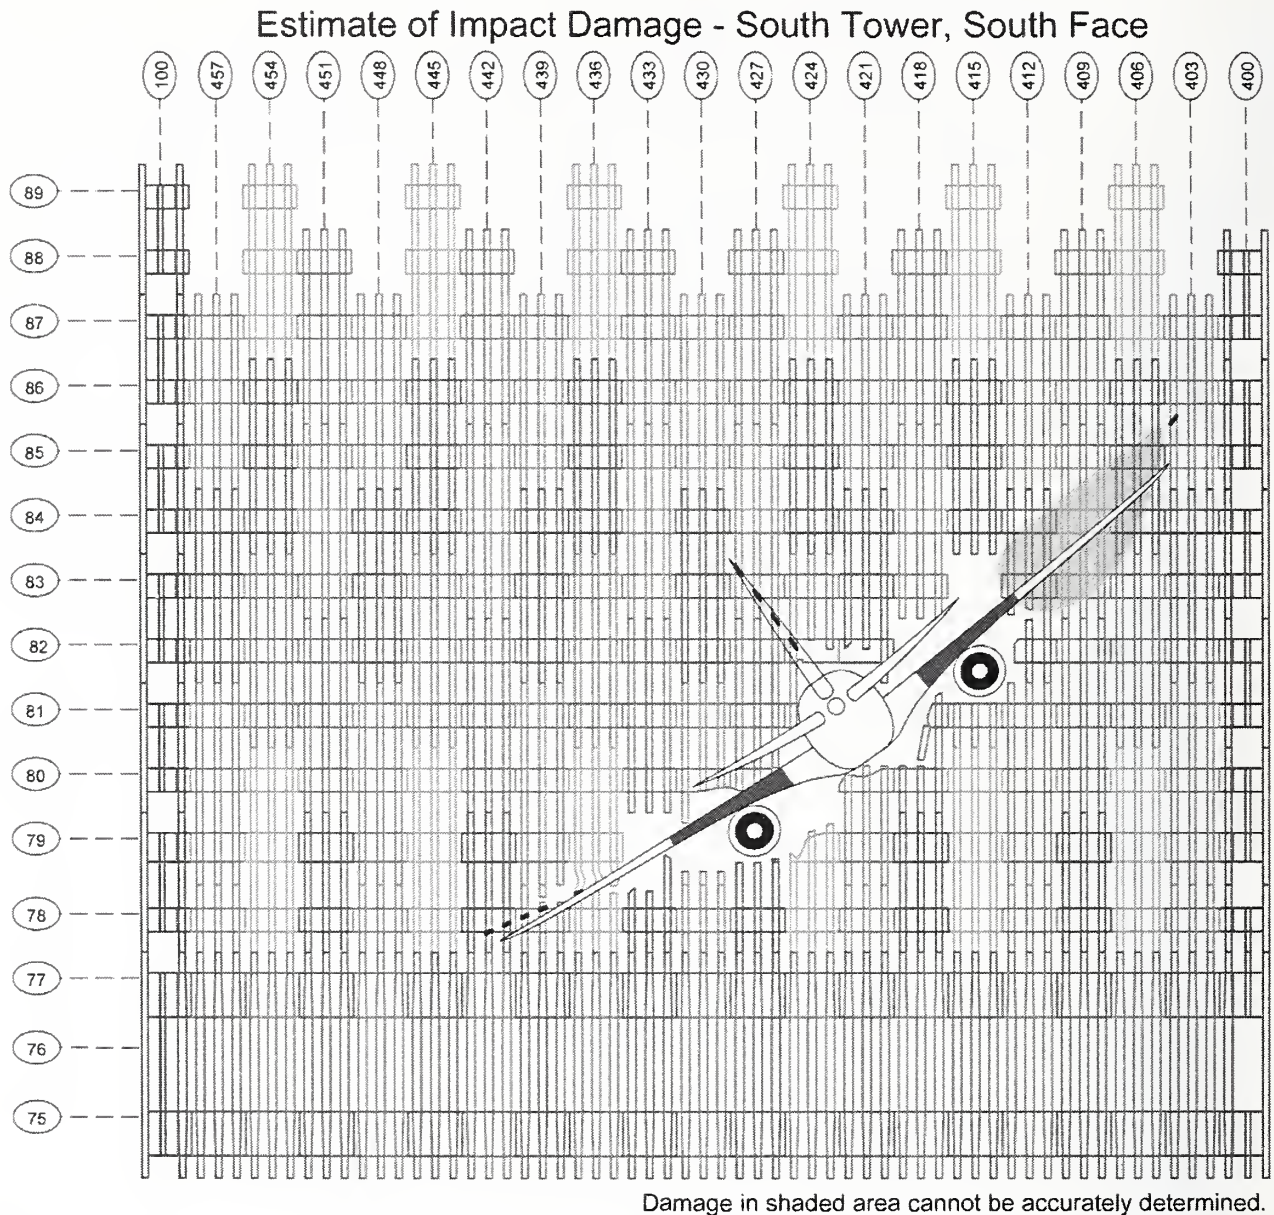
Figure E-3. A scaled outline of a Boeing 767-200ER is superimposed on the damage diagram for the south face of WTC 2. The position of the aircraft has been adjusted to best match the damage pattern and marks showing where the wing tips and vertical stabilizer struck. The red areas correspond to the approximate locations of fuel on the aircraft based on an analysis reported elsewhere (NCSTAR 1-2B).

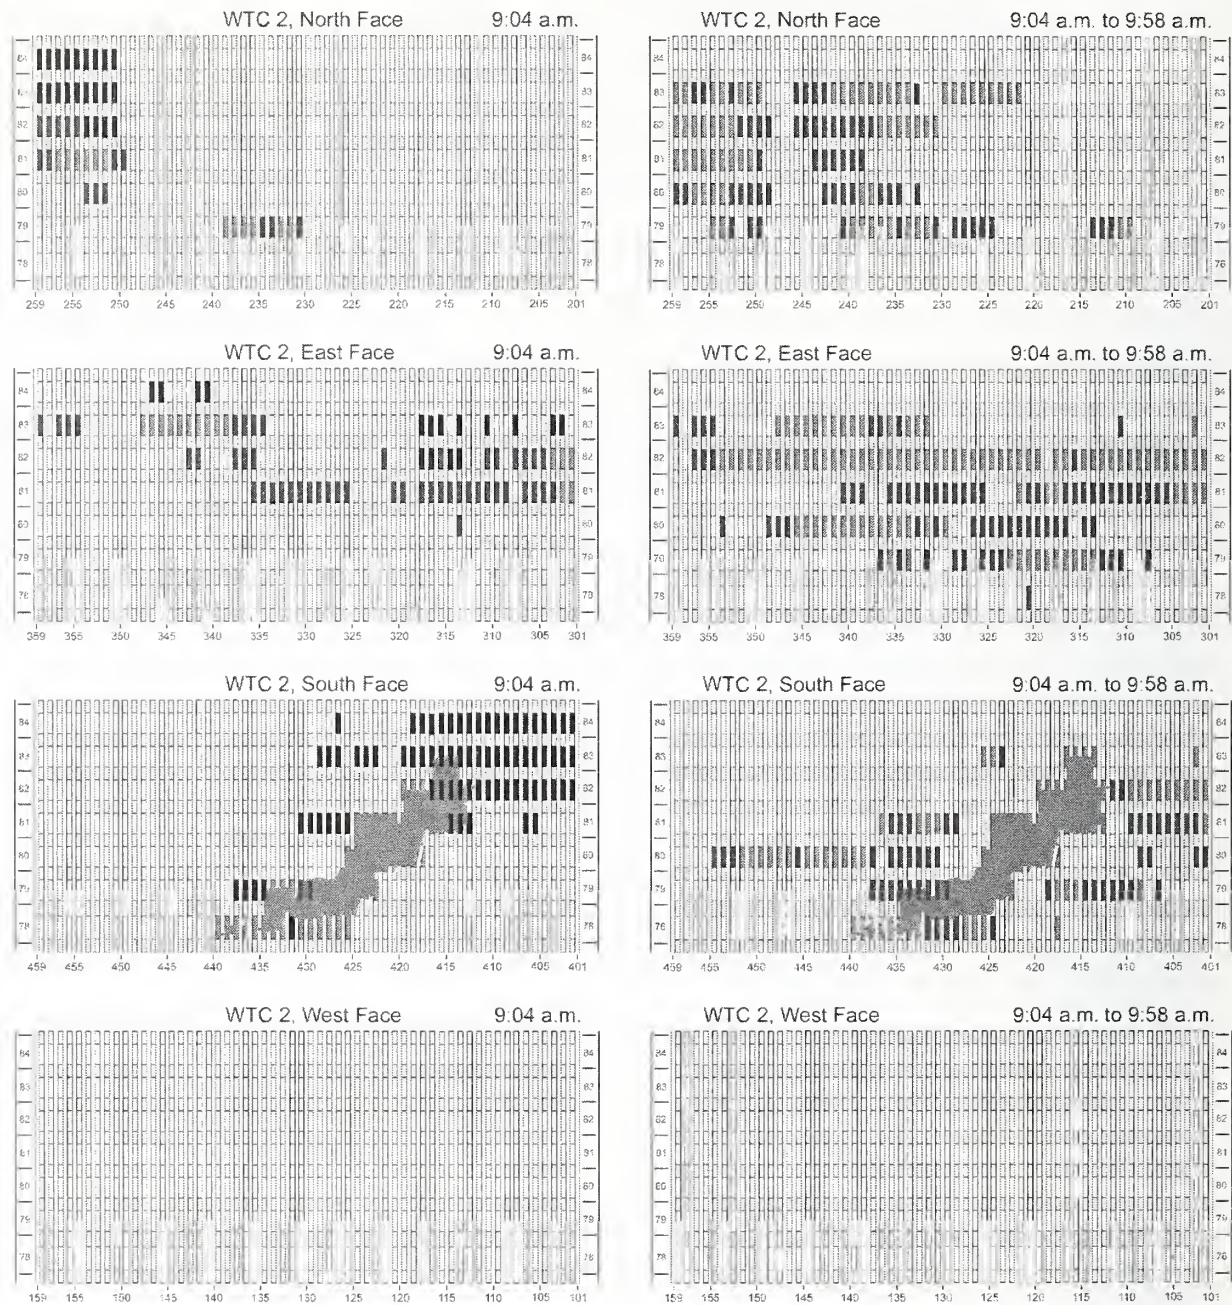
Figure E-18. Maps of observed fire distributions on the four faces of WTC 2 shortly after the aircraft impact (near 9:04 a.m.) are compared with the corresponding integrated fire observations for the entire period between 9:03 a.m. and 9:59 a.m. Blue represents windows where observations were not possible.

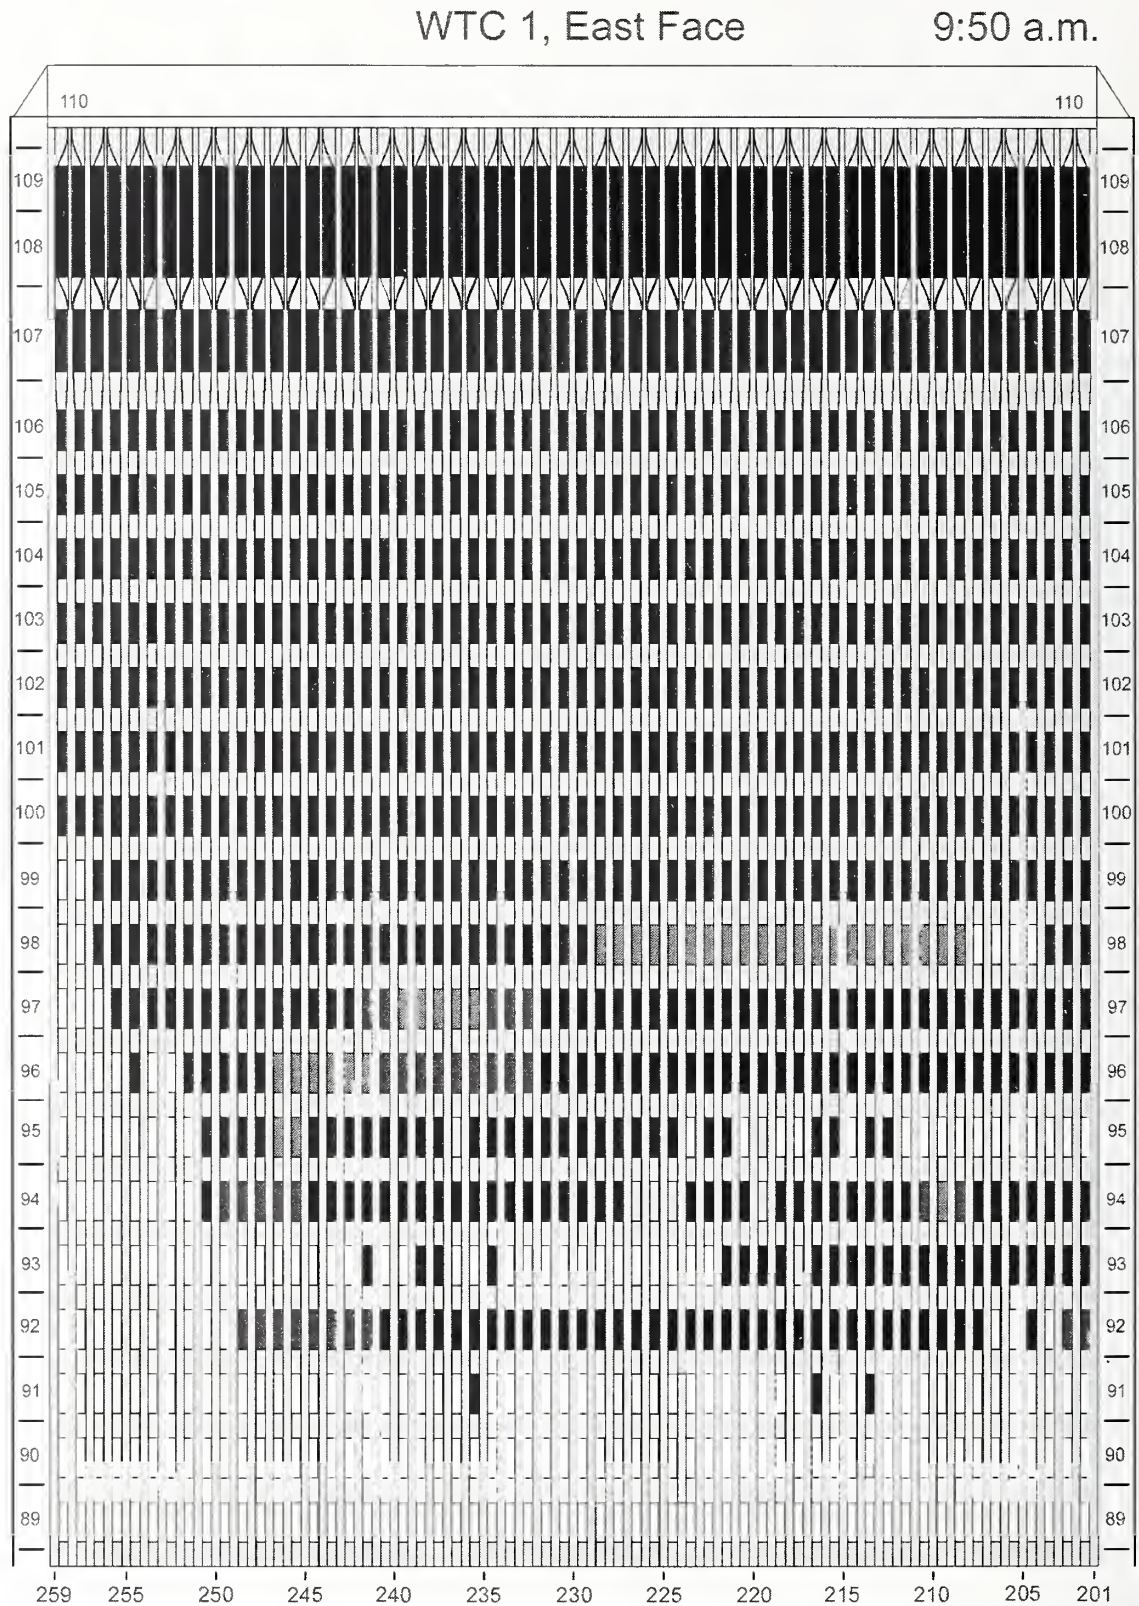
Figure 5-6. An example of a façade drawing combining data for window condition and fires is shown. The data is for the east face of WTC 1 around 9:50 a.m.

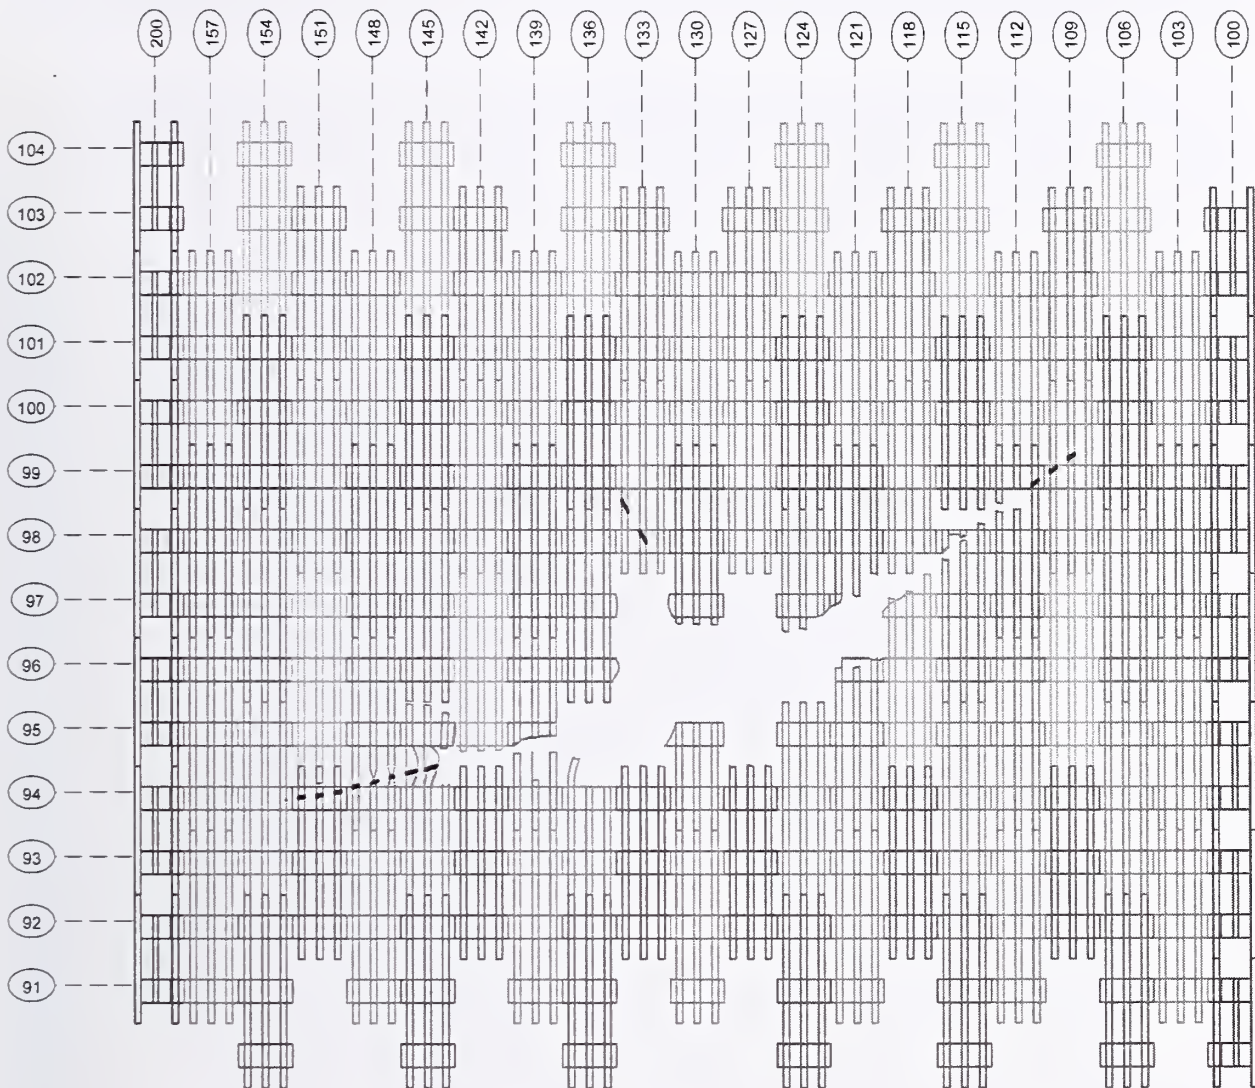
Figure 6-6. A drawing shows the aircraft impact damage to the steel façade of WTC 1. The dark dotted lines indicate locations where the wings and vertical stabilizer of the aircraft marked the aluminum cladding on columns.

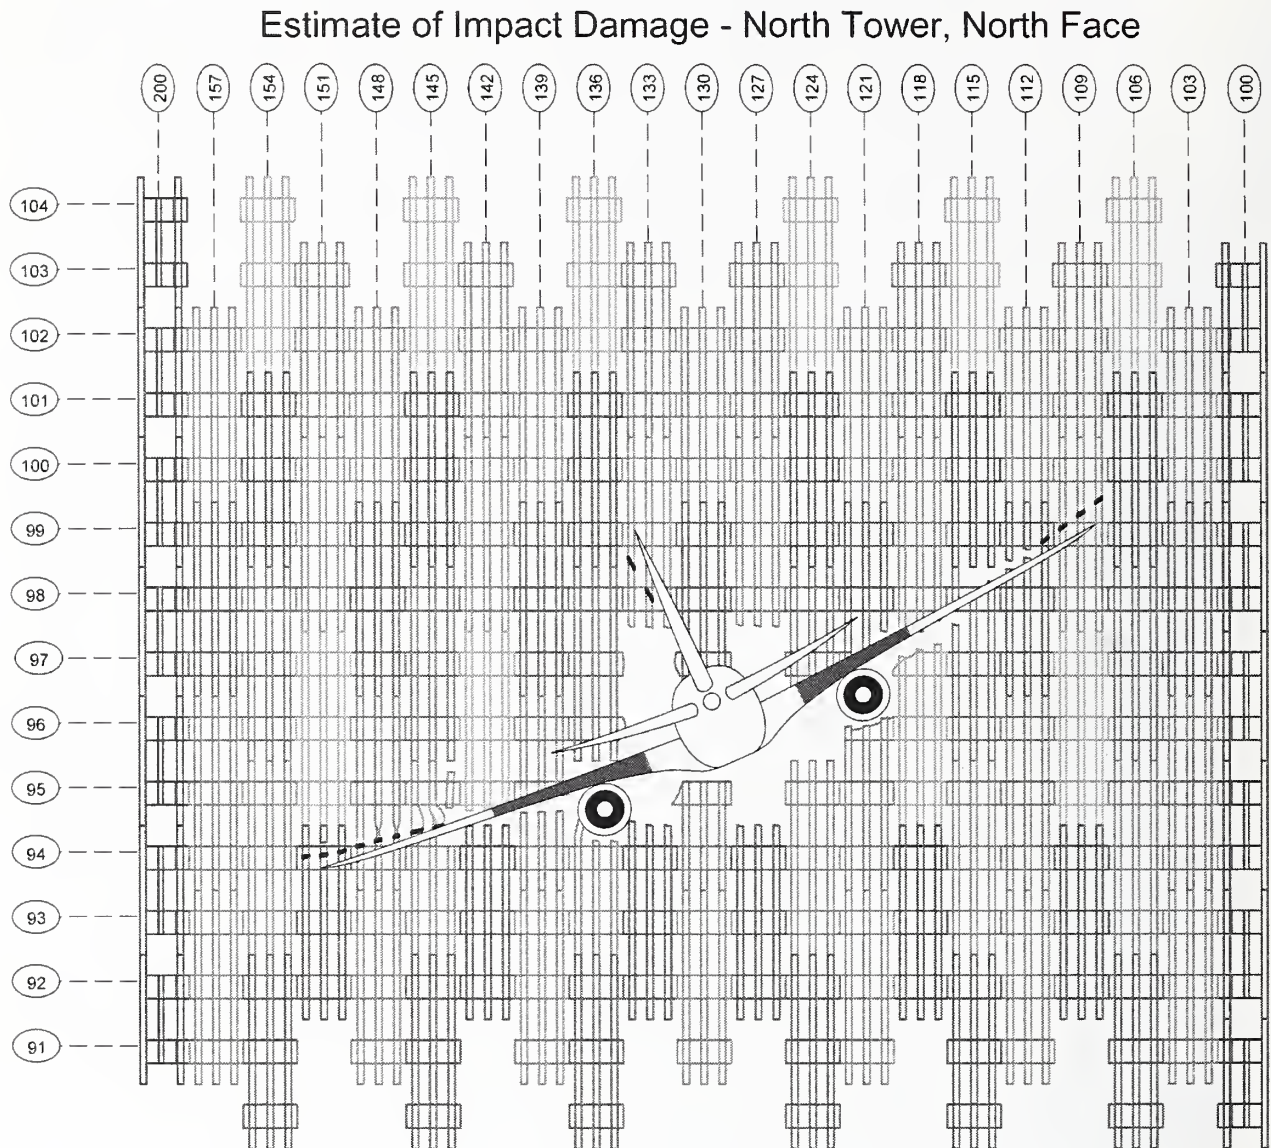
Figure 6-7. A scaled outline of a Boeing 767-200ER is superimposed on the damage diagram shown in Figure 6-6. The position of the aircraft has been adjusted to give the best match with the damage pattern and marks showing where the wing tips and vertical stabilizer struck. The red areas correspond to the approximate locations of fuel on the aircraft based on an analysis reported elsewhere (NIST NCSTAR 1-2B).

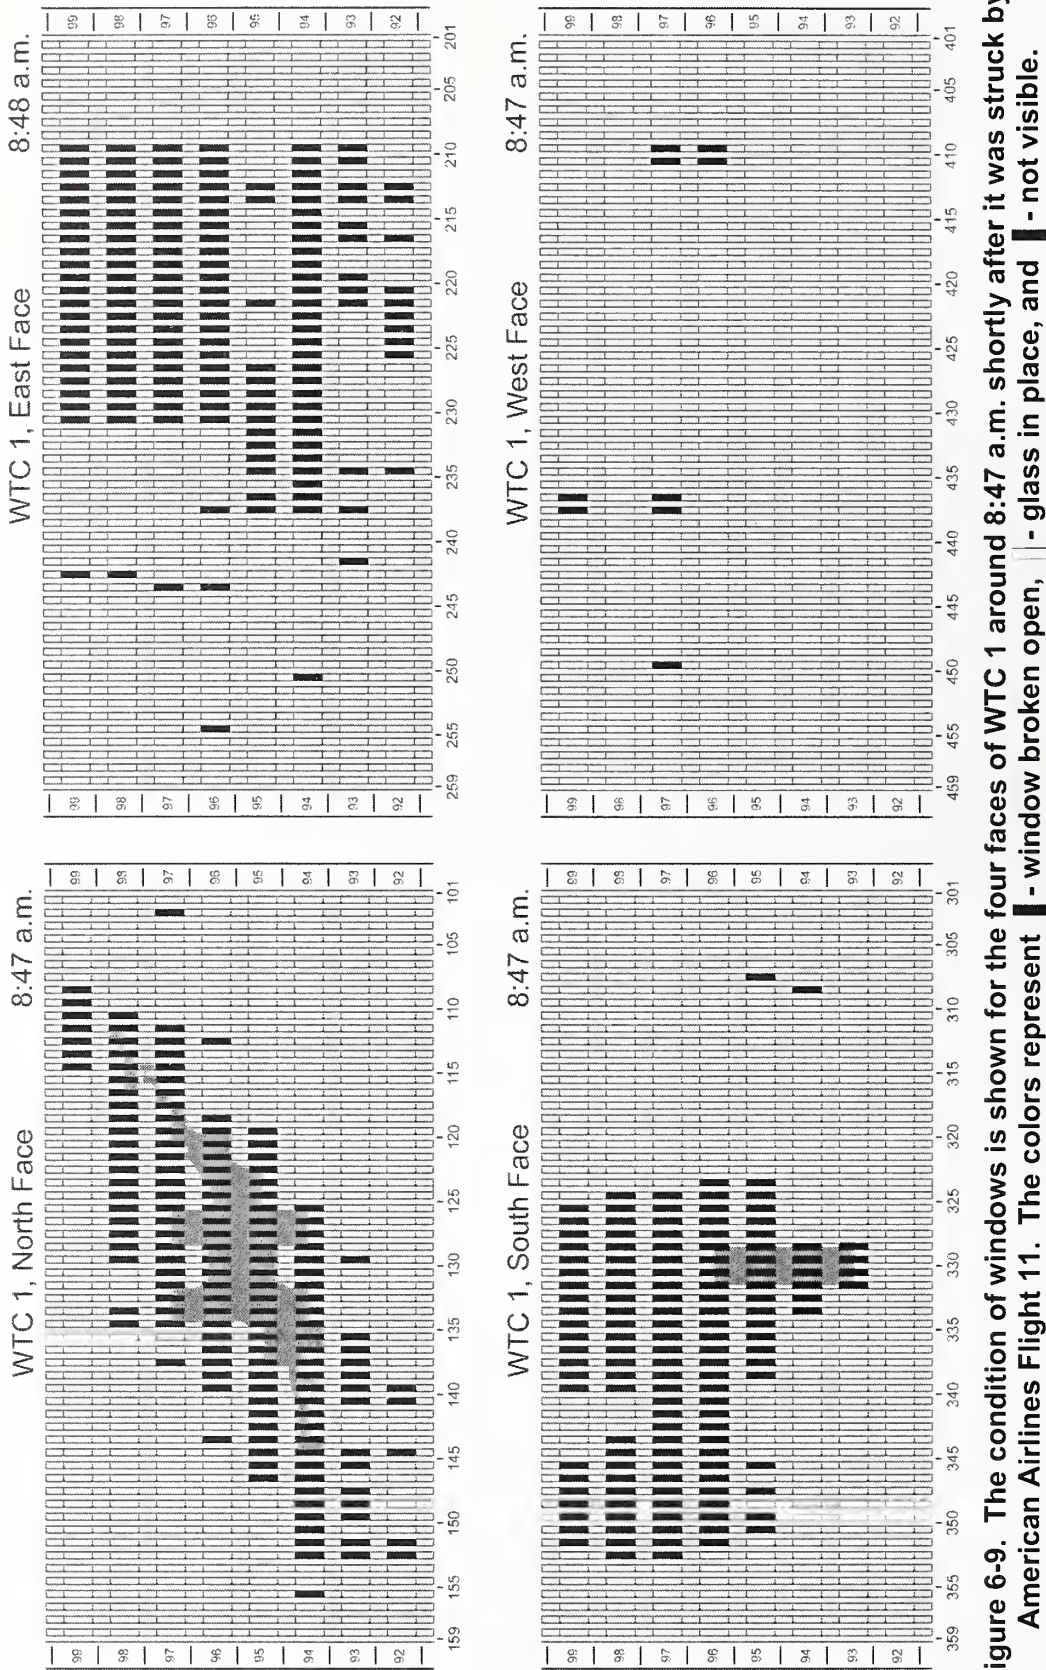
Figure 6-9. The condition of windows is shown for the four faces of WTC 1 around 8:47 a.m. shortly after it was struck by American Airlines Flight 11. The colors represent ■ - window broken open, □ - glass in place, and ▒ - not visible.

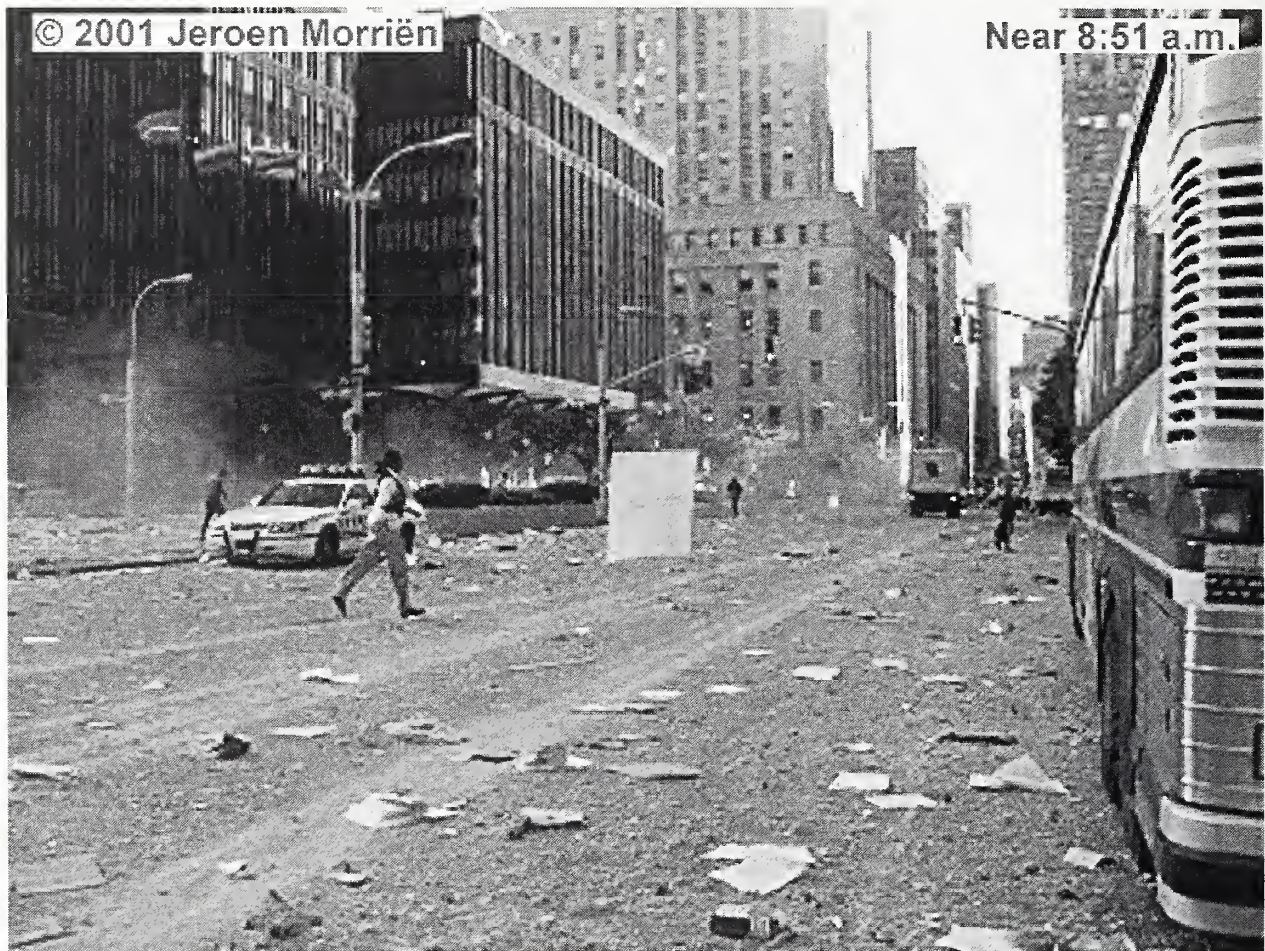
Figure 6-14. A photograph recorded around 8:51 a.m. shows debris present on Church Street, which ran along the east side of the WTC complex. WTC 5 is located on the left-hand side.

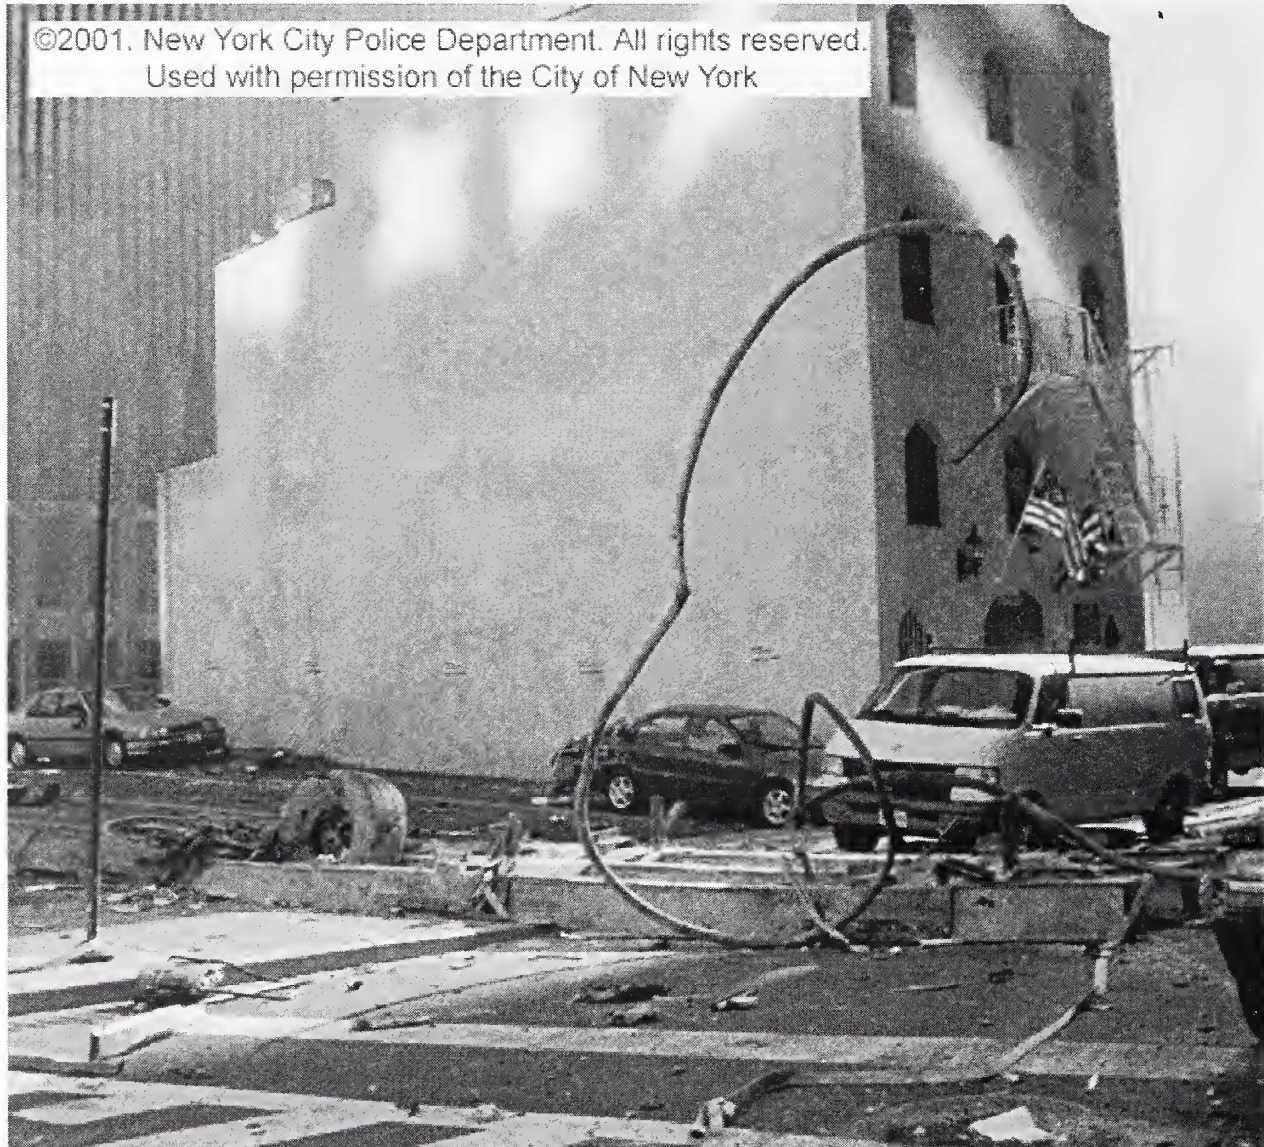
Figure 6-16. Photograph showing a full steel panel section lying in Cedar Street near its intersection with West Street. An aircraft wheel is embedded in one of the windows. The building behind the panel is Saint Nicholas Greek Orthodox Church and the lower section of WTC 2 can be seen across Liberty Street.

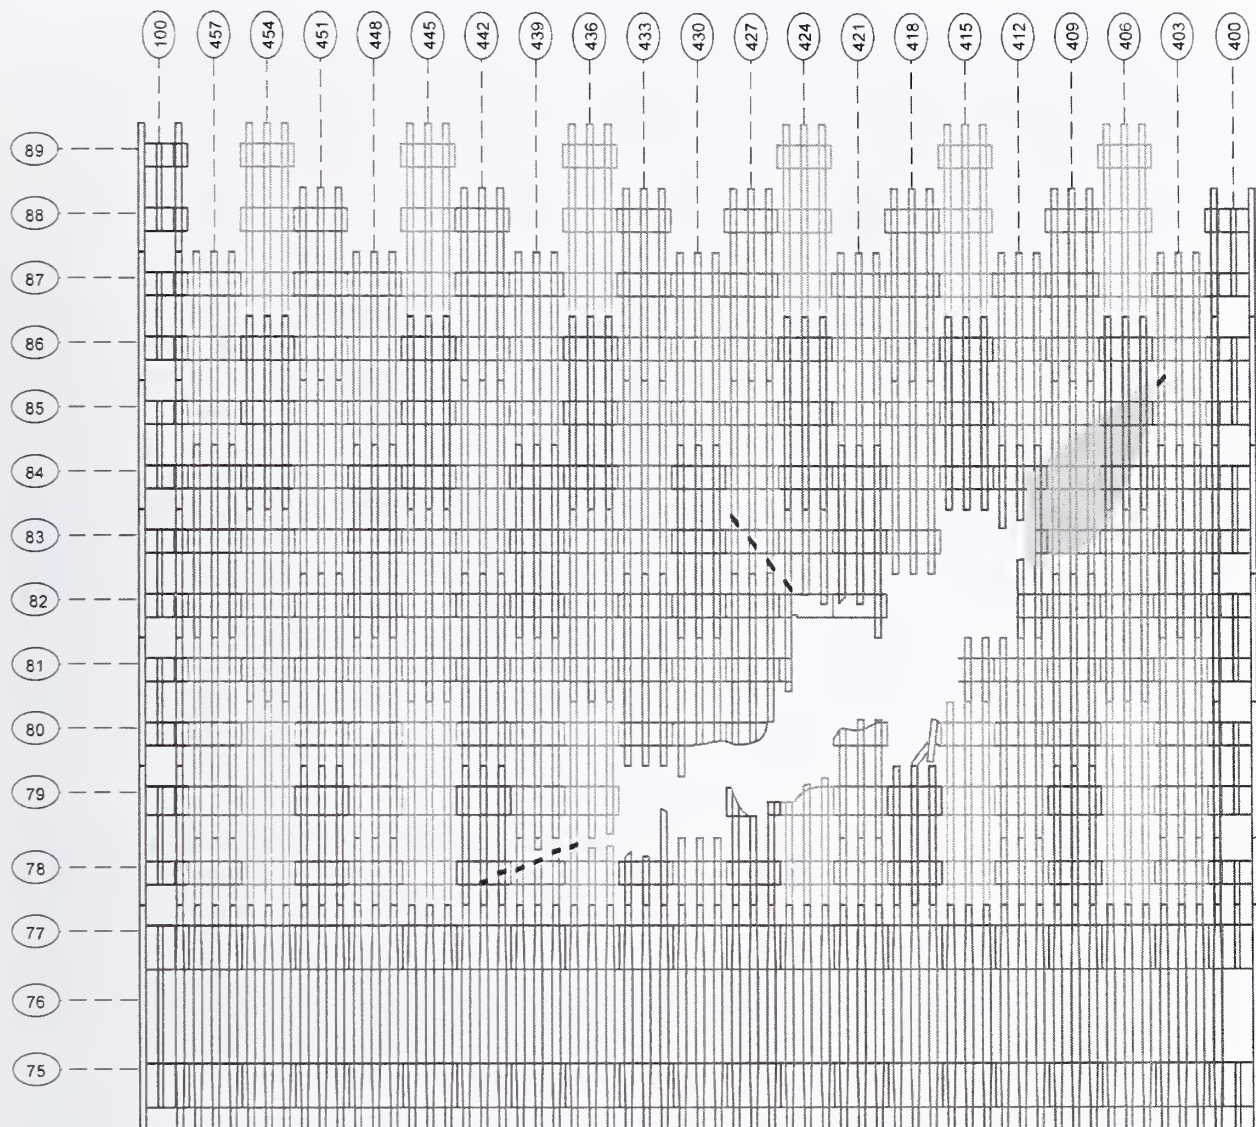
Damage in shaded area cannot be accurately determined.

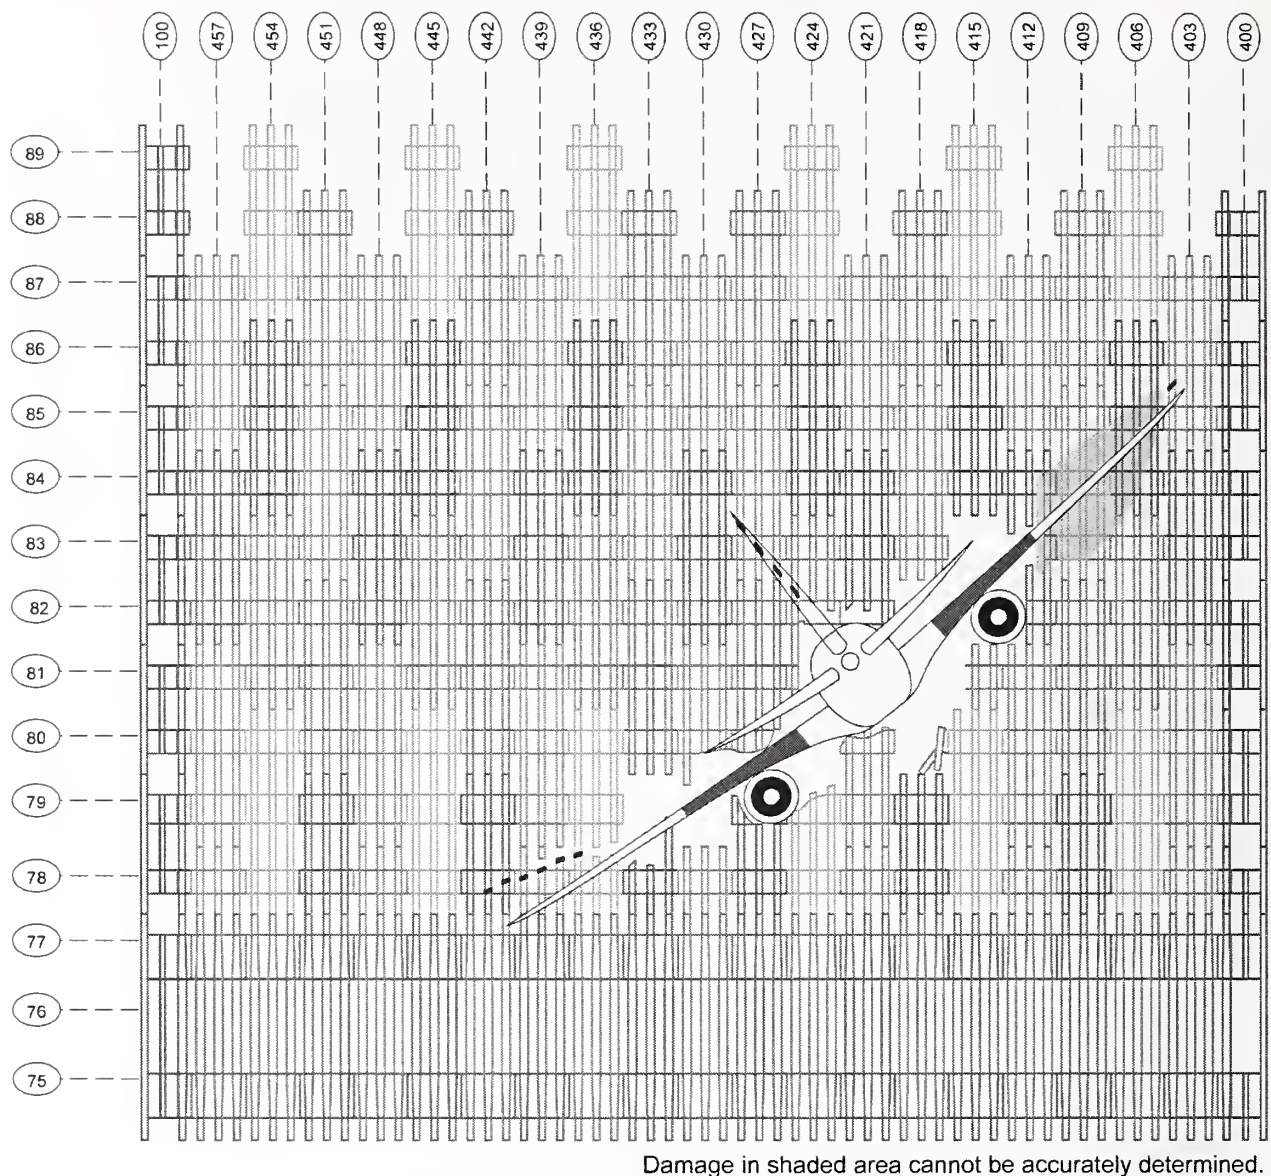
Figure 7-26. A scaled outline of a Boeing 767-200ER is superimposed on the damage diagram shown in Figure 7-25. The position of the aircraft has been adjusted to give the best match with the damage pattern and marks showing where the wing tips and vertical stabilizer struck. The match is not expected to be perfect since the drawing shows the aircraft as it appears when on the ground. The red areas correspond to the approximate locations of fuel on the aircraft based on an analysis reported elsewhere (NCSTAR 1-2B).

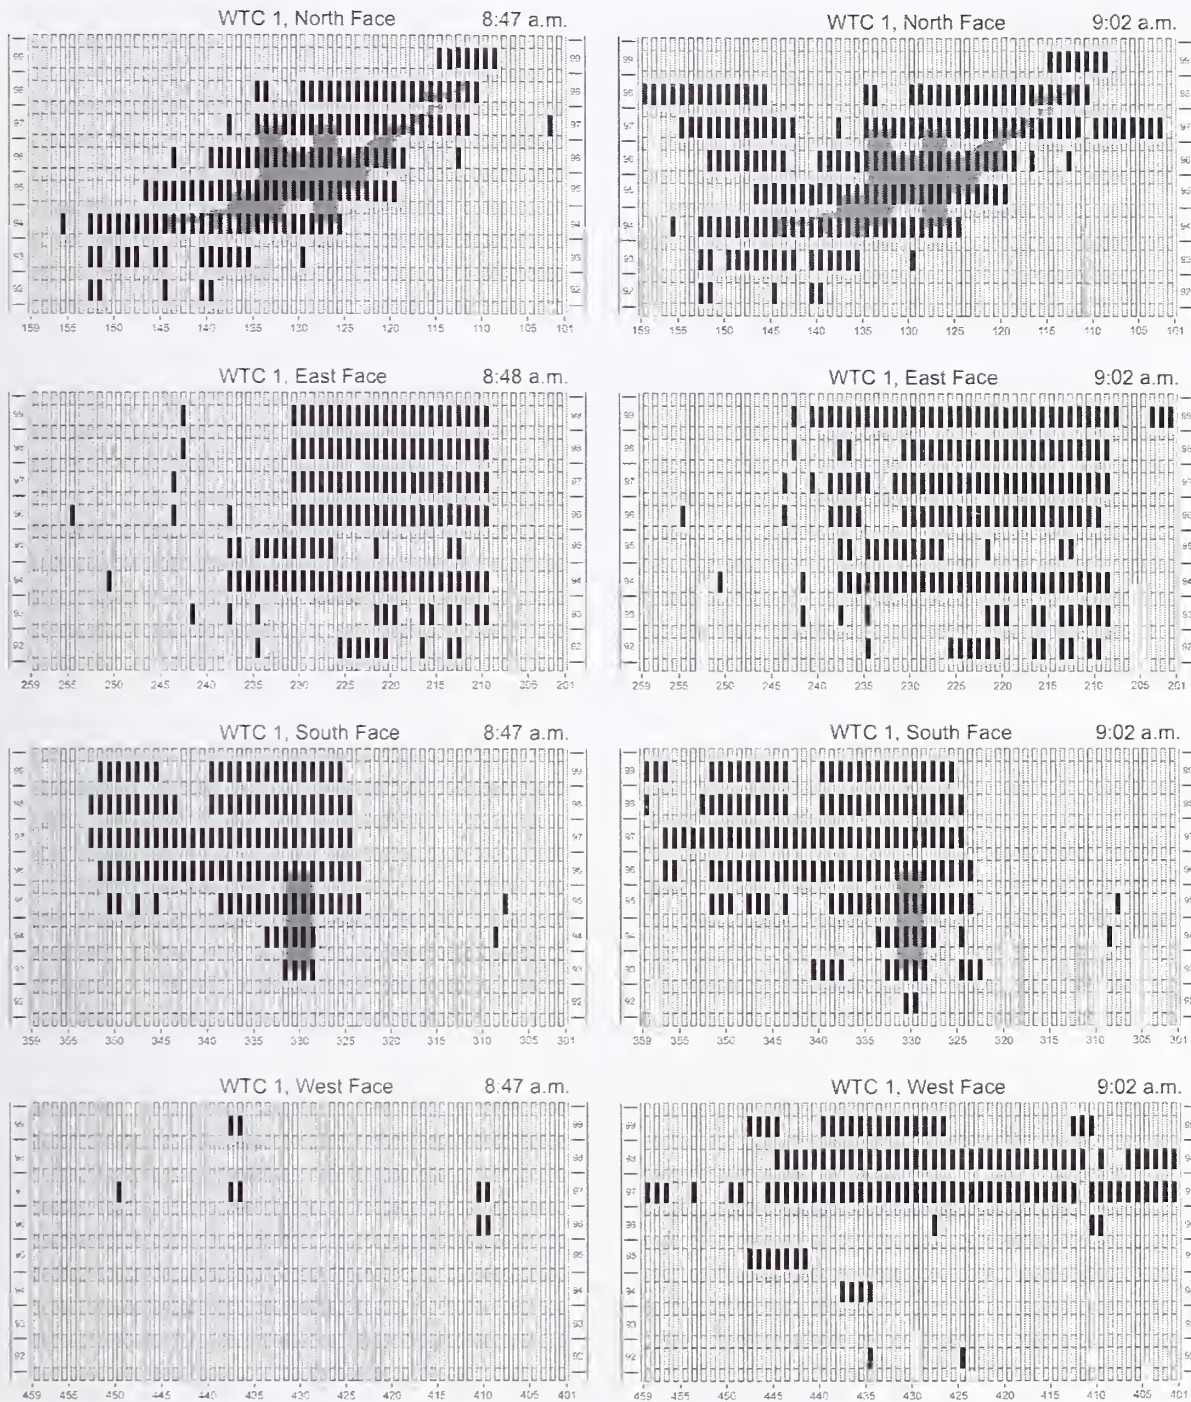
Figure 8-13. Maps for the 92nd through the 99th floors compare missing window glass for the four faces of WTC 1 at two times, shortly after the aircraft impact and roughly 15 minutes later. The color coding used for the maps is indicated in Figure 5-1.

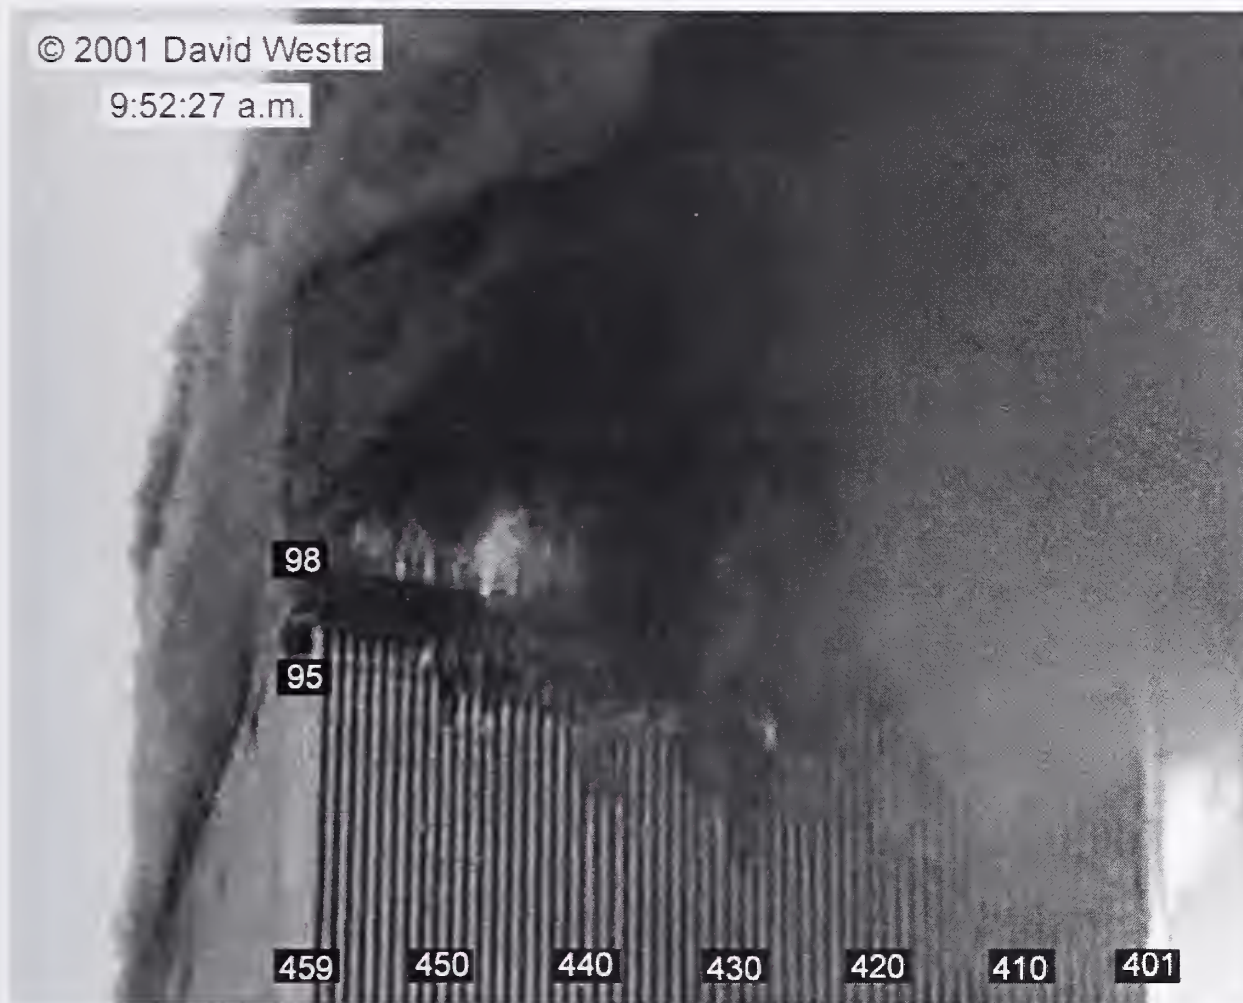
Figure 8-64. This cropped photograph shows the south face of WTC 1 at 9:52:27 a.m. The intensity levels have been adjusted and column and floor numbers have been added. For reference purposes, the missing aluminum panel on the southwest corner of the towers is on the 96th floor, and the heaviest fire is on the 98th floor.
